PBCE
PBCF

(PROPELLER BOSS CAP FIN)

INSTALLED UNDERWATER IN-SITU

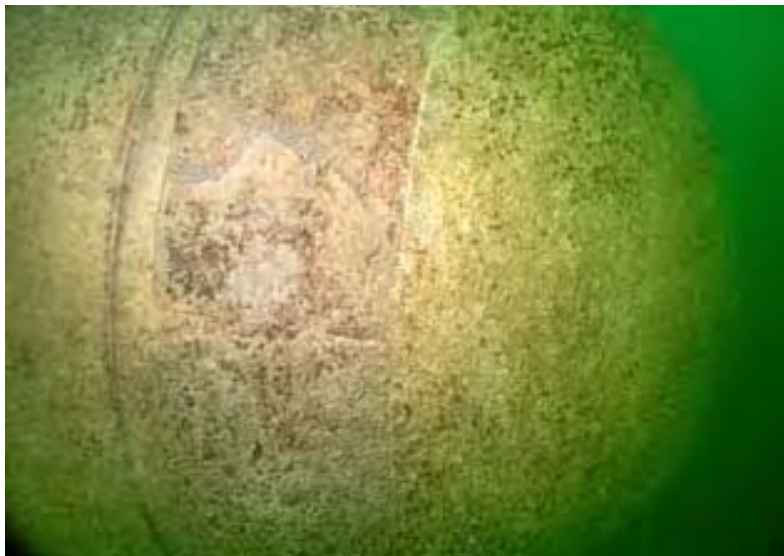
PHOTOGRAPH SHOWING THE PROPELLER BOSS BEFORE REMOVAL

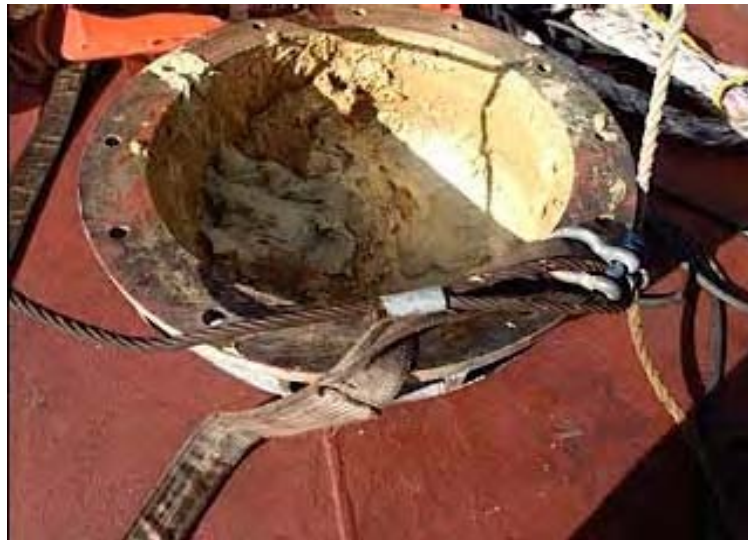
PHOTOGRAPH SHOWING THE PROPELLER BOSS
ON THE BACK OF THE VESSEL

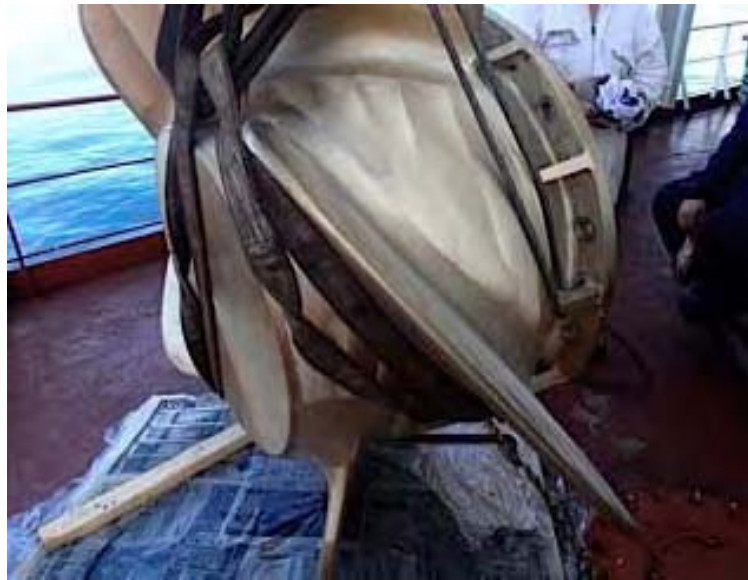
PHOTOGRAPH SHOWING THE NEW PBFC
ON THE BACK OF THE VESSEL

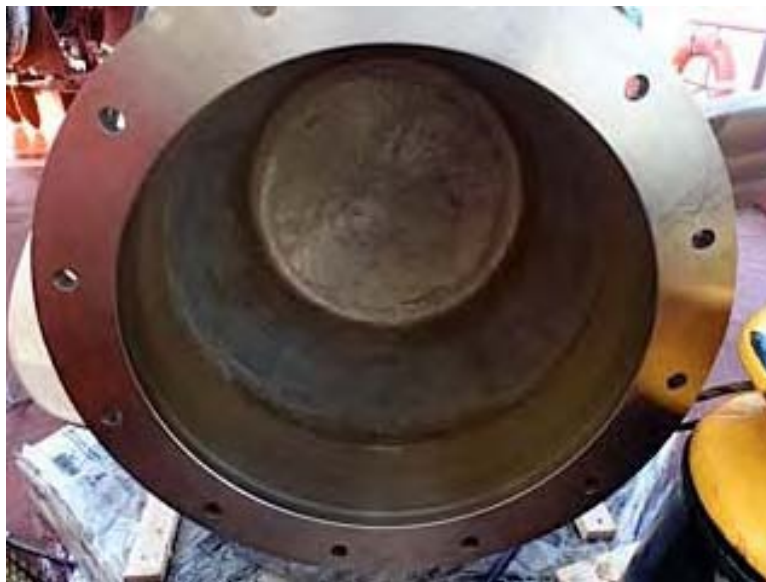
PHOTOGRAPH SHOWING THE NEW PBFC BEFORE GREASING

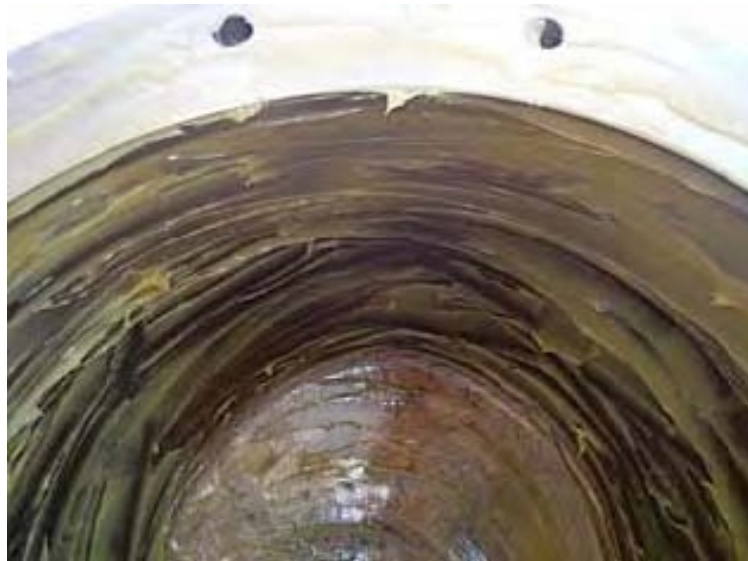
PHOTOGRAPH SHOWING THE NEW PBFC AFTER GREASING

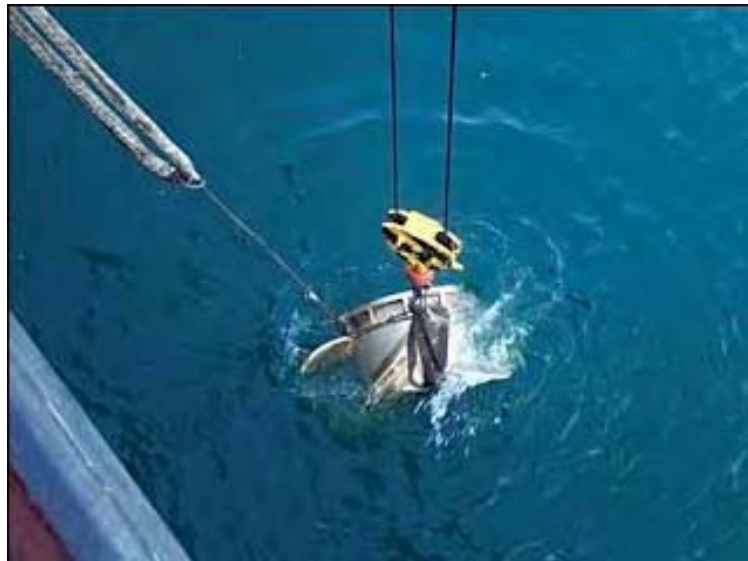
PHOTOGRAPH SHOWING
THE NEW PBFC BEING LOADED INTO THE WATER

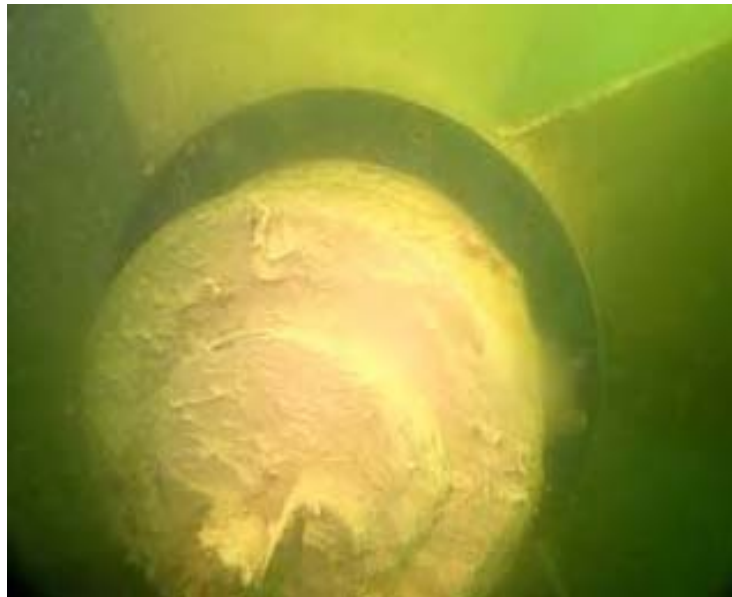
PHOTOGRAPH SHOWING THE PROPELLER CONE
AFTER GREASING BY THE DIVERS

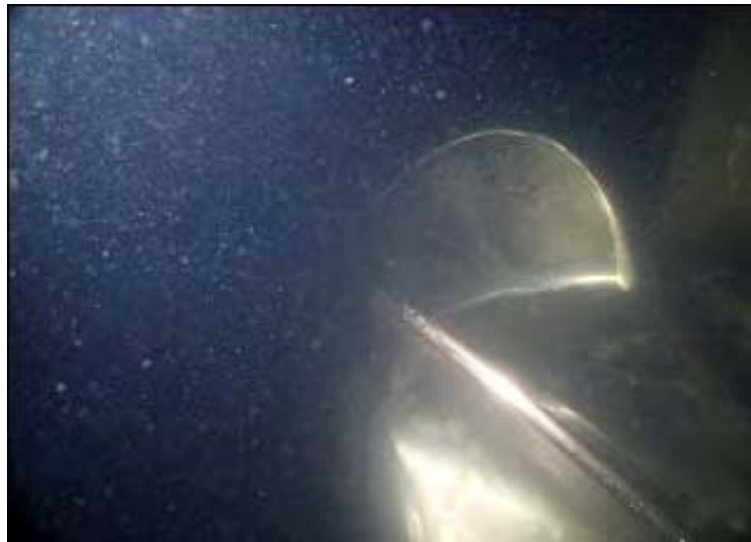
PHOTOGRAPH SHOWING THE NEW PBFC IN POSITION

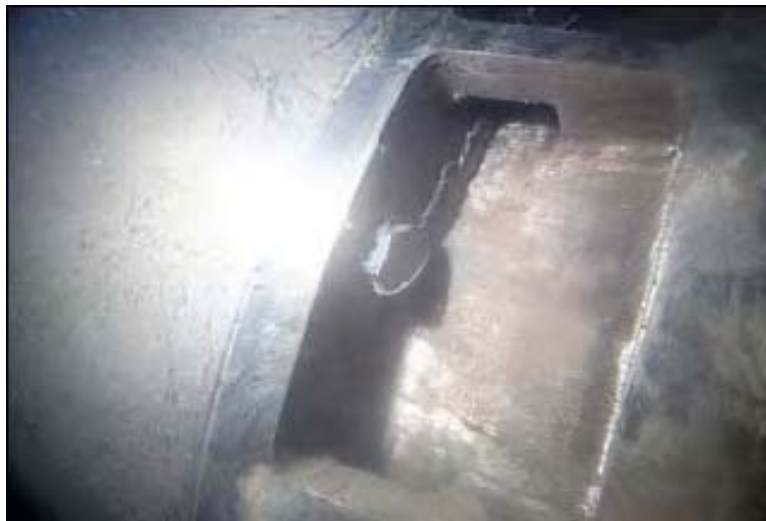
PHOTOGRAPH SHOWING THE NEW PBCF AFTER THE BOLTS
TORQUE WRENCH TO THE SPECIFICATION MANUAL AND
AFTER THE BOLTS WERE SEIZED UP

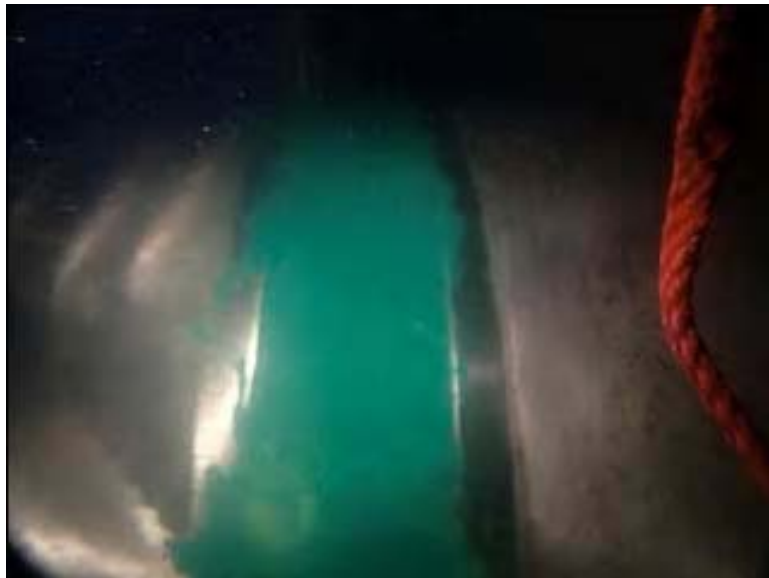
PHOTOGRAPH SHOWING THE NEW PBFC IN PLACE AND
AFTER THE RECESSES WERE FILLED WITH UNDERWATER TWO PART
EPOXY CEMENT

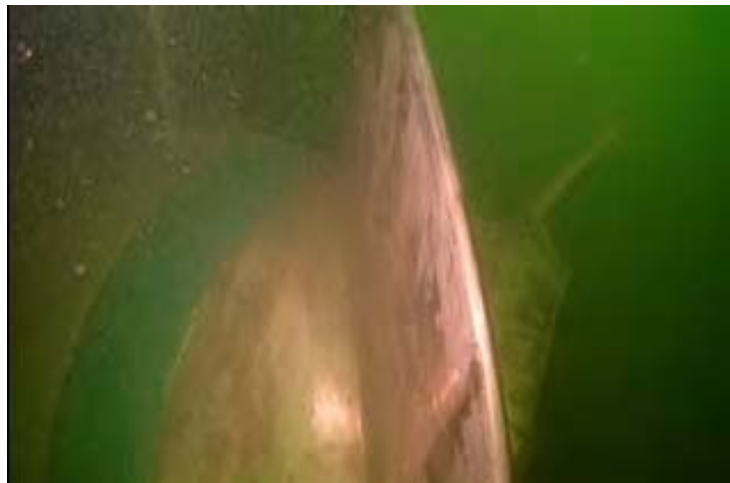
PHOTOGRAPH SHOWING THE NEW PBFC IN PLACE AND
AFTER THE RECESSES WERE FILLED WITH UNDERWATER TWO PART
EPOXY CEMENT BEFORE POLISHING

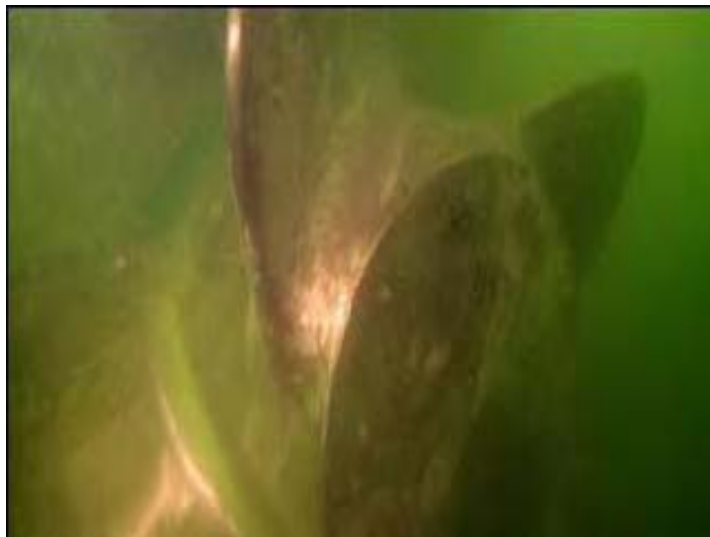
PHOTOGRAPH SHOWING THE NEW PBFC IN PLACE AND
AFTER THE RECESSES WERE FILLED WITH UNDERWATER TWO PART
EPOXY CEMENT BEFORE POLISHING

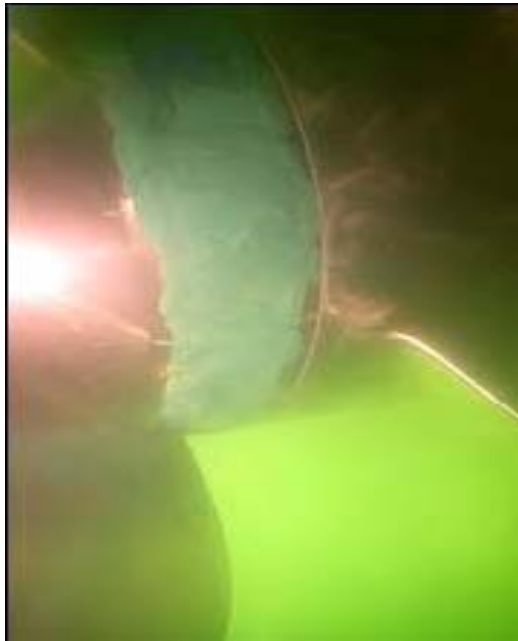
PHOTOGRAPH SHOWING THE NEW PBCF IN PLACE AND
AFTER THE RECESSES WERE FILLED WITH UNDERWATER TWO PART
EPOXY CEMENT AFTER POLISHING

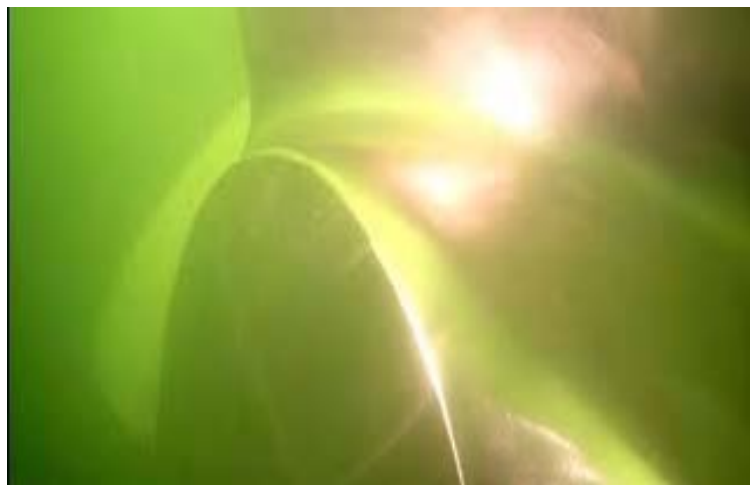
PHOTOGRAPH SHOWING THE NEW PBCF IN PLACE AND
AFTER THE RECESSES WERE FILLED WITH UNDERWATER TWO PART
EPOXY CEMENT AFTER POLISHING

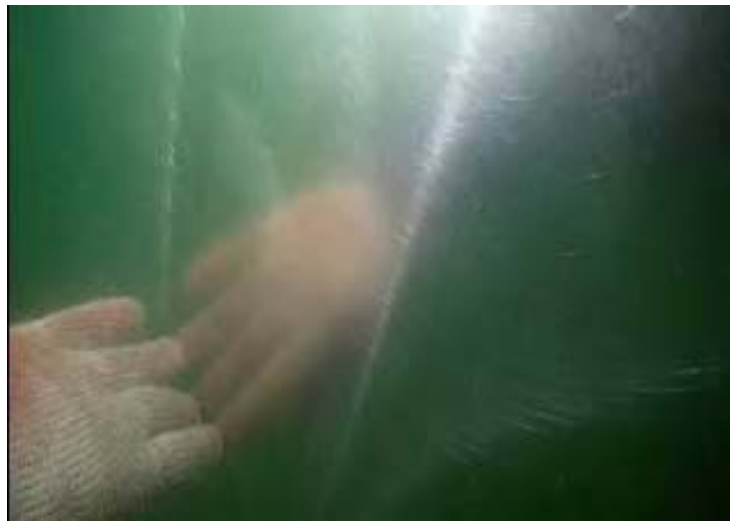
PHOTOGRAPH SHOWING THE NEW PBFC IN PLACE AND
AFTER THE RECESSES WERE FILLED WITH UNDERWATER TWO PART
EPOXY CEMENT AFTER POLISHING AND
SHOWING THE DIVER'S REFLECTION

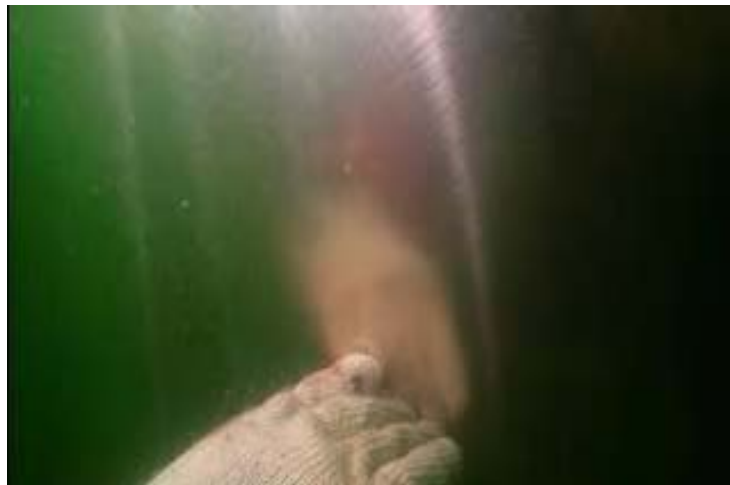
PHOTOGRAPH SHOWING THE NEW PBFC IN PLACE AND
AFTER THE RECESSES WERE FILLED WITH UNDERWATER TWO PART
EPOXY CEMENT AFTER POLISHING AND
SHOWING THE DIVER'S REFLECTION

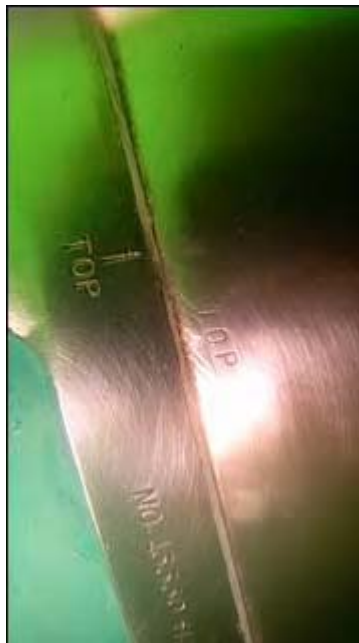
PHOTOGRAPH TAKEN SHOWING THE ROOT MARKINGS ON
COMPLETION OF THE INSTALLATION AND POLISHING
